# Crown Puncture Repair Training Guide

- Passenger Tires
- Light Truck Tires
- Truck Tire
- Retread Repair Only

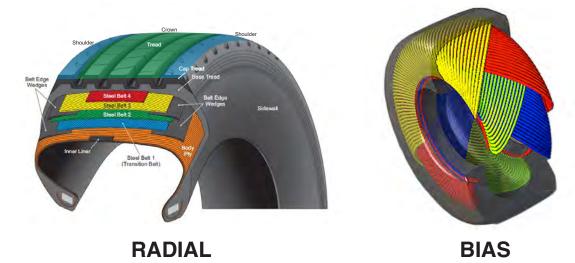
## **Tire Construction Basics**

When inflating a tire, the tire must be strong enough to contain the inflation pressure. Due to this pressure, tires are reinforced with either fabric or steel body plies that wrap around the bead bundle. The bead bundle is a steel wire hoop that holds the tire firmly against the rim and prevents the tire from leaking or slipping.

The two most common types of tires used in the industry are bias and radial ply. Bias ply tires have body plies that wrap around one bead and run diagonally across the tire and wrap around the opposite bead. Bias tires will always have at least two layers of body plies that wrap around the tire in alternating directions and intersect in the crown at nearly a right angle. The nature of the flexing of bias tires allows for greater distortion in the tread area, typically leading to a faster wear rate than radial tires, as well as lower fuel economy.

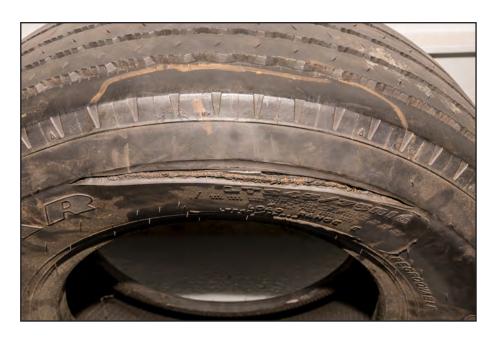
Zipper Rupture in a Light Truck Tire with steel body plies.

Zipper ruptures are circumferential ruptures in the sidewall caused by operating the tire in an under inflated and/or overloaded condition. These conditions allow for over flexing of the sidewall which can result in overheating of the casing and potential catastrophic tire failure. It is always recommended to inflate these tires with the valve core removed, in a safety cage with a clip-on chuck and sufficient length of air hose to keep the technician away from the sidewall of the tire during the inflation process.

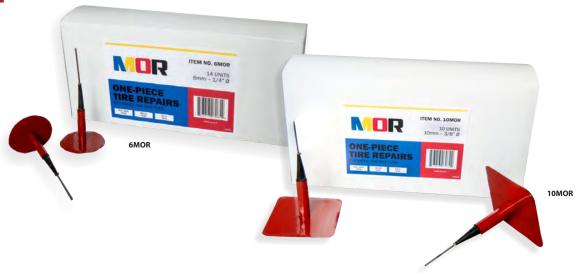
## MOR One-Piece Repairs

MOR One-Piece Repairs are patch/plug units designed for puncture repairs in the crown area of passenger, LT and truck tires. One-piece repairs feature chemical cushion gum both on the repair base and stem, providing maximum adhesion in the injury and to the inner liner of the tire. MOR One-Piece Repairs also feature a lead wire on the stem for easy installation of the repair unit. All MOR One-Piece Repairs can be installed in any radial or bias tire.

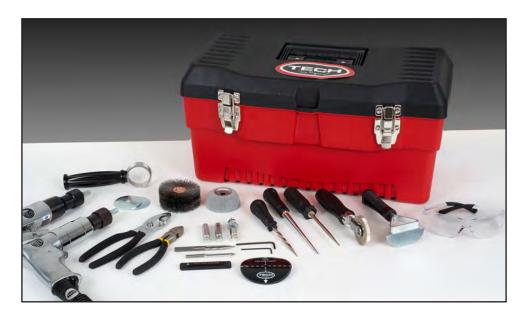
## TECH Service Truck Nail Hole Tool Kit

- Comes fully assembled and ready to use
- Sturdy lockable case for security and convenience
- Transportable for ease of use while doing field repairs

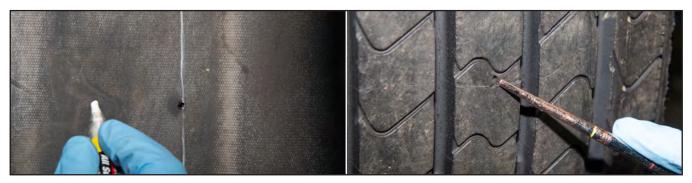
## Tire Inspection & Pre-Cleaning

1. Locate and mark all damage on the inside and outside of the tire while checking for separation.

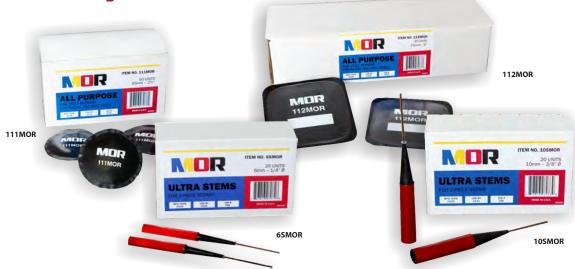
The MOR Two-Piece Repair System is designed to produce a safe, permanent repair for LT, medium, and heavy duty truck tires. A proper two-piece repair consists of a vulcanizing rubber stem or rope rubber to fill and permanently seal the injury channel, in conjunction with a separate repair unit which reinforces the tire and seals the inner liner. This repair system meets all tire industry guidelines for proper puncture repairs.

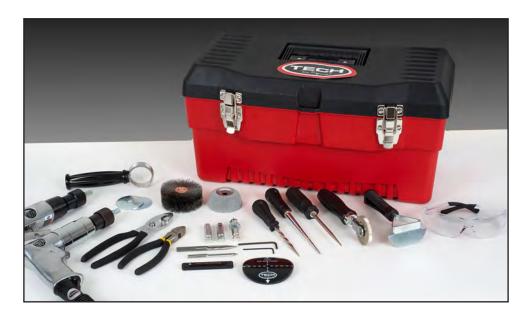
## TECH Service Truck Nail Hole Tool Kit

- · Comes fully assembled and ready to use
- Sturdy lockable case for security and convenience
- Transportable for ease of use while doing field repairs

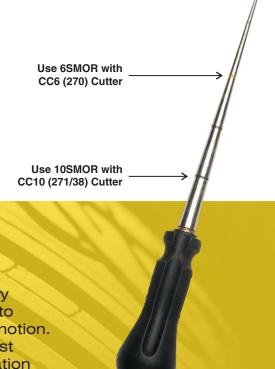
Insert the TRT105 measuring tool into the injury from the inside of the tire. Apply firm pressure to the handle while rotating the tool in a circular motion. When the tool meets resistance, find the closest visible line to the inner liner. Refer to the illustration (right) to determine the injury size and angle.
