Instructions for Uni-Seal Premium Patch/Plug Repairs

PASSENGER & LIGHT TRUCK TIRES

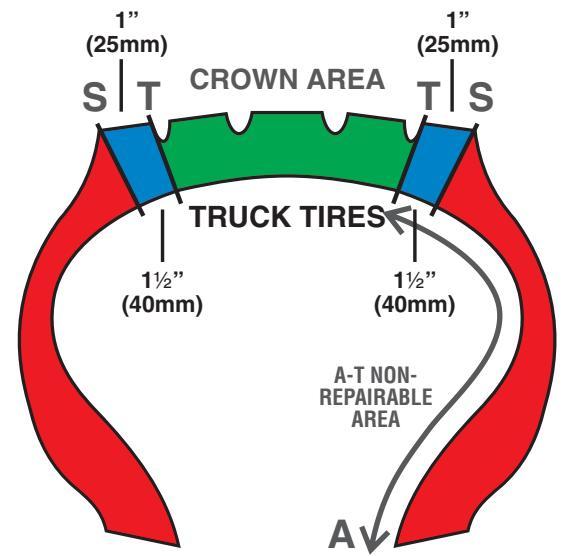
The use of a two-piece repair is required if the angle of the injury exceeds 35 degrees.

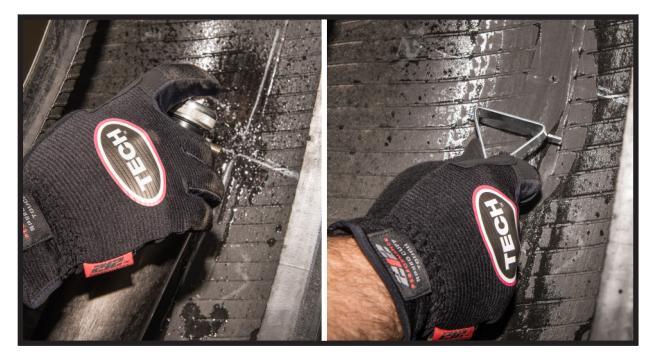
Pre-clean the inner liner 2-3 times with CLC-704 Liquid Rubber Buff and a scraper to remove contaminants.

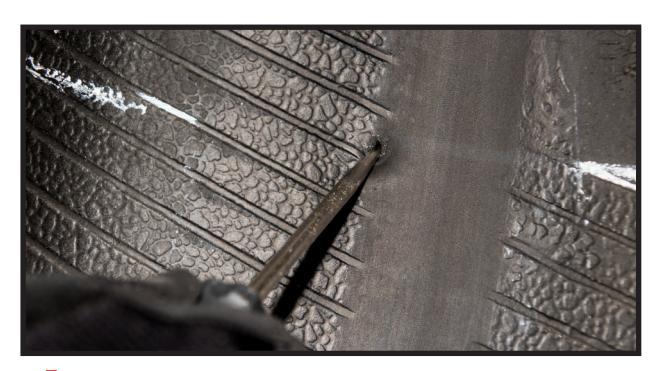
Remove the tire from the wheel. Inspect the tire for damage and defects that would make the tire non-repairable. Locate and mark all damage on the inside and outside of the tire. Insert a spiral cement tool or a probe into the injury from the inside of the tire to determine the size and angle of the injury.

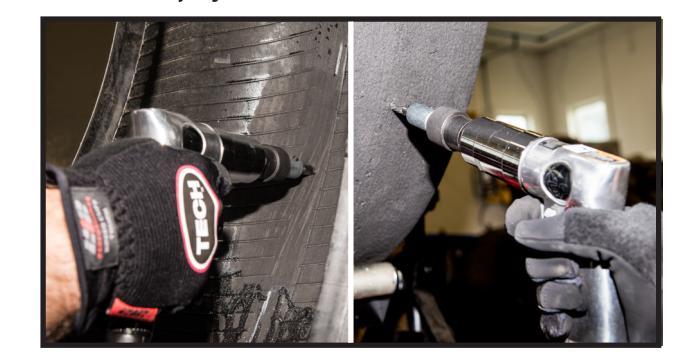
Damaged rubber and steel should be removed from the injury using a carbide cutter on a low speed air/electric drill, maximum 1,200 RPM. Drill the injury from the inside of the tire 3 to 5 times. Repeat this process from the outside.

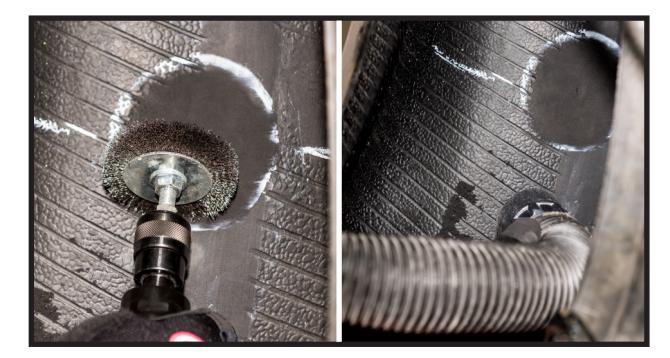
Use a soft wire brush followed by a vacuum to remove buffing dust and debris from the buffed area.

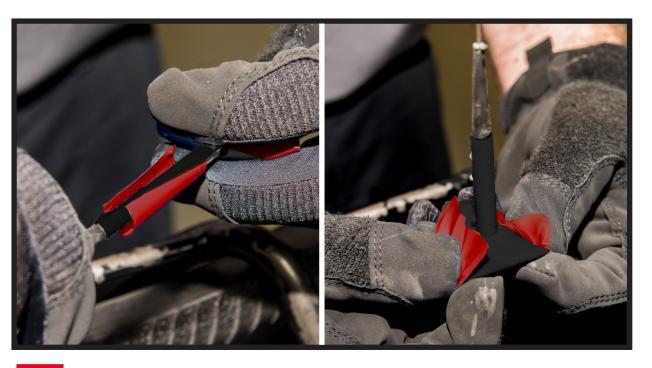
Remove the red poly from the stem by pulling and twisting the repair as shown. Reposition the poly on the cap.

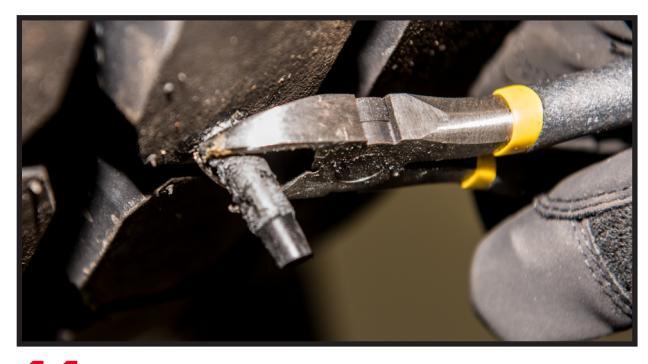
1 With the stem relaxed, cut off the excess stem 1/8" (3mm) above the tread surface. The tire is ready to be returned to service.
